# **Pumping Station 7 Force Main**

**Emergency Repair Update**

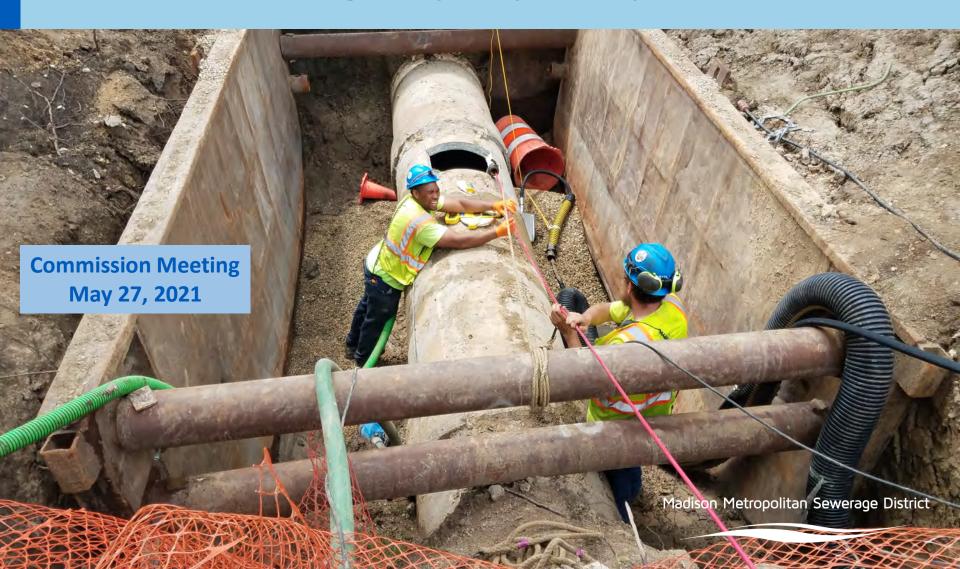
### April 5<sup>th</sup> – Leak Discovered in Median of Beltline

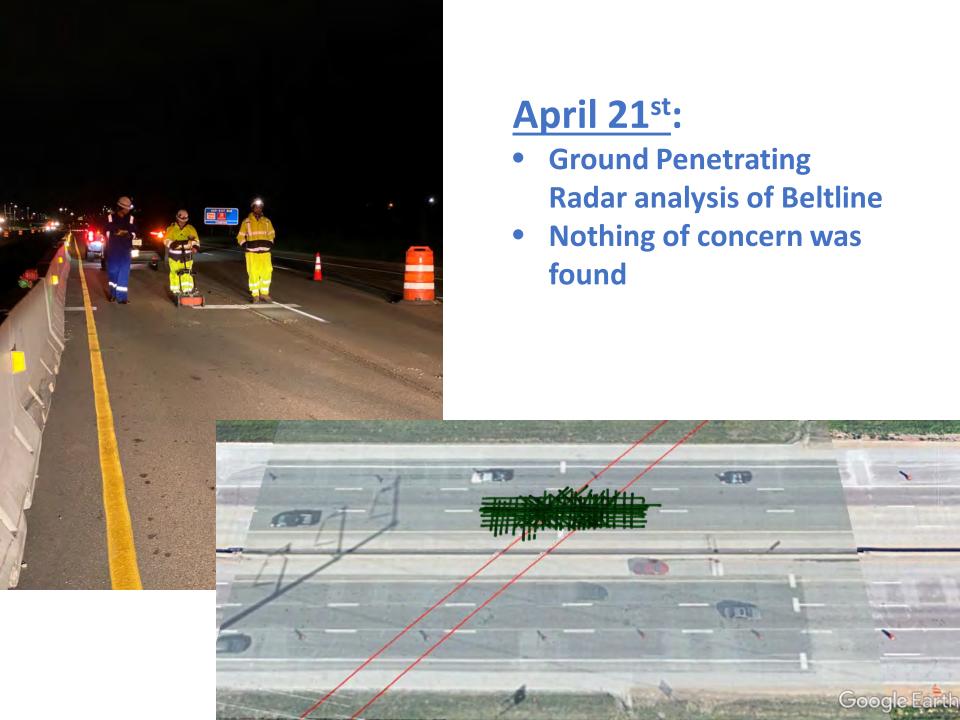
- Excavation in median of Beltline
- Is leak location visible?
  - Answer: No
- Which force main is leaking?
  - Seepage above 1948 force main
  - Dry around 1963 force main
- Hunch:
  - 1948 force main is leaking

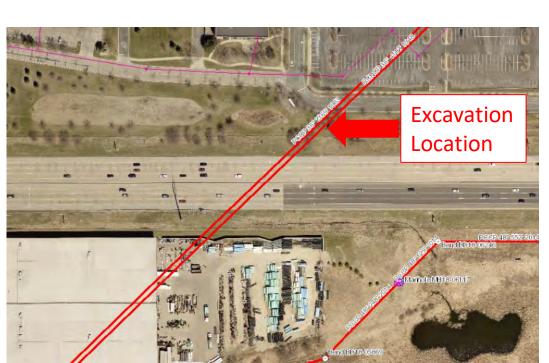
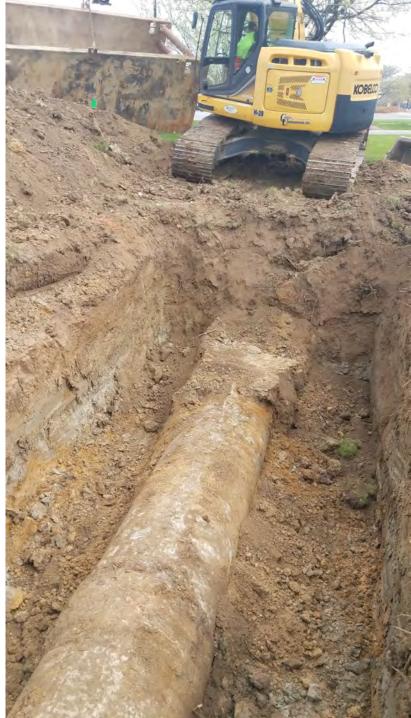
- Pipe excavated on north side of Beltline
- To determine pipe size for repair parts and clamp
- Also access point for internal inspection and lining

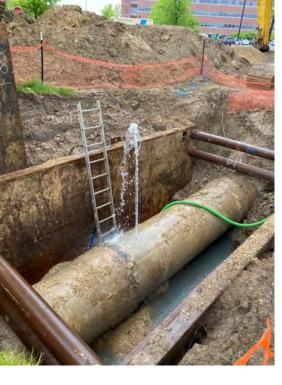
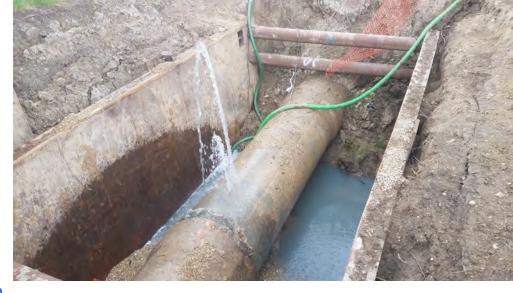
• Repair clamp arrives

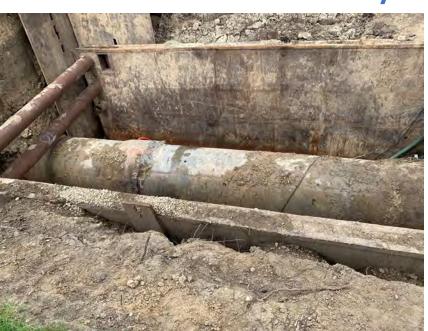
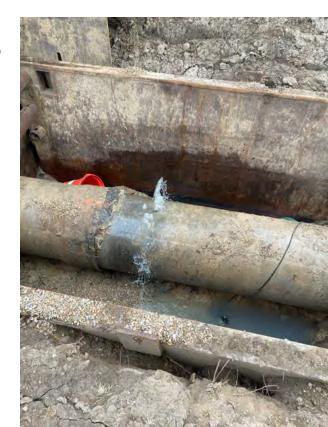
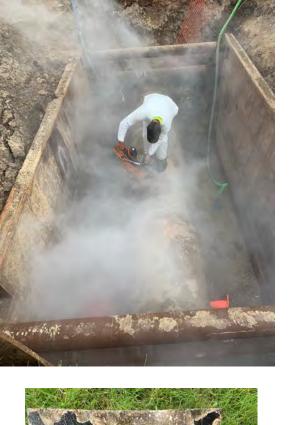
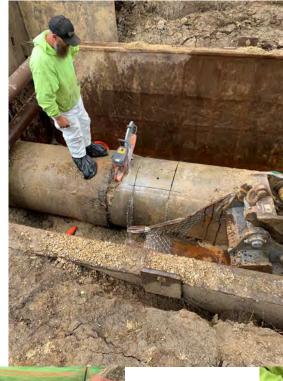
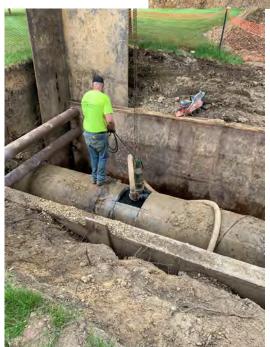
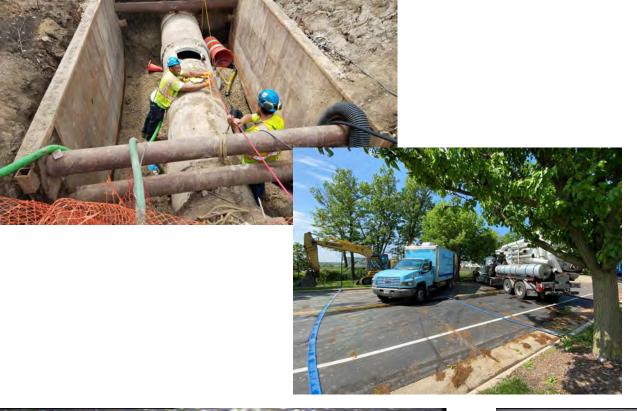
- Draining process begins
- 3 days to complete

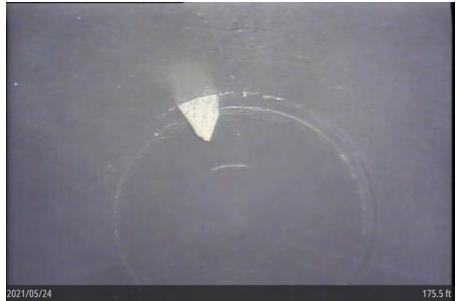
- Internal inspection
- Cracked pipe 182' from entry point
- Location: Median of the Beltline
- Confirms: 1948 force main was leaking

- Confident 1948 force main was leaking
- Line across entire Beltline right-of-way
- 346' of internal liner required
- 4-6 weeks to receive materials (liner and resin)
- Order closure pipe and clamps for both sides also
- Approximately \$50,000 spent to date
- Total cost estimate: ~\$300K
