Odana Hills Recharge System

- Built by MG&E and UW-Madison
- Draws stormwater from pond
- Filters water
- Pumps to subsurface infiltration bed
- Recharges ~50 million gallons per year to groundwater

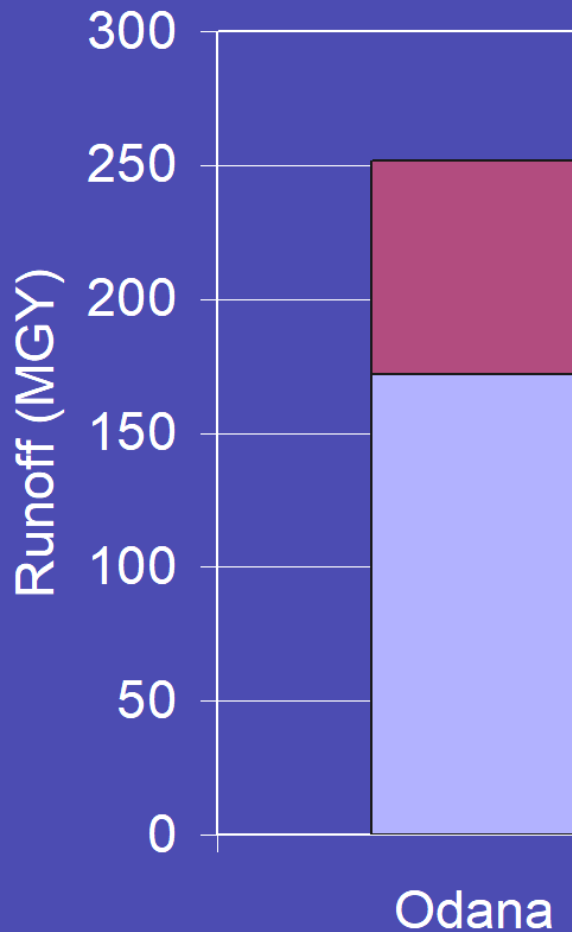
Runoff Available to Meet Recharge Goal

Remaining Water Budget 80 MGY Recharge Goal

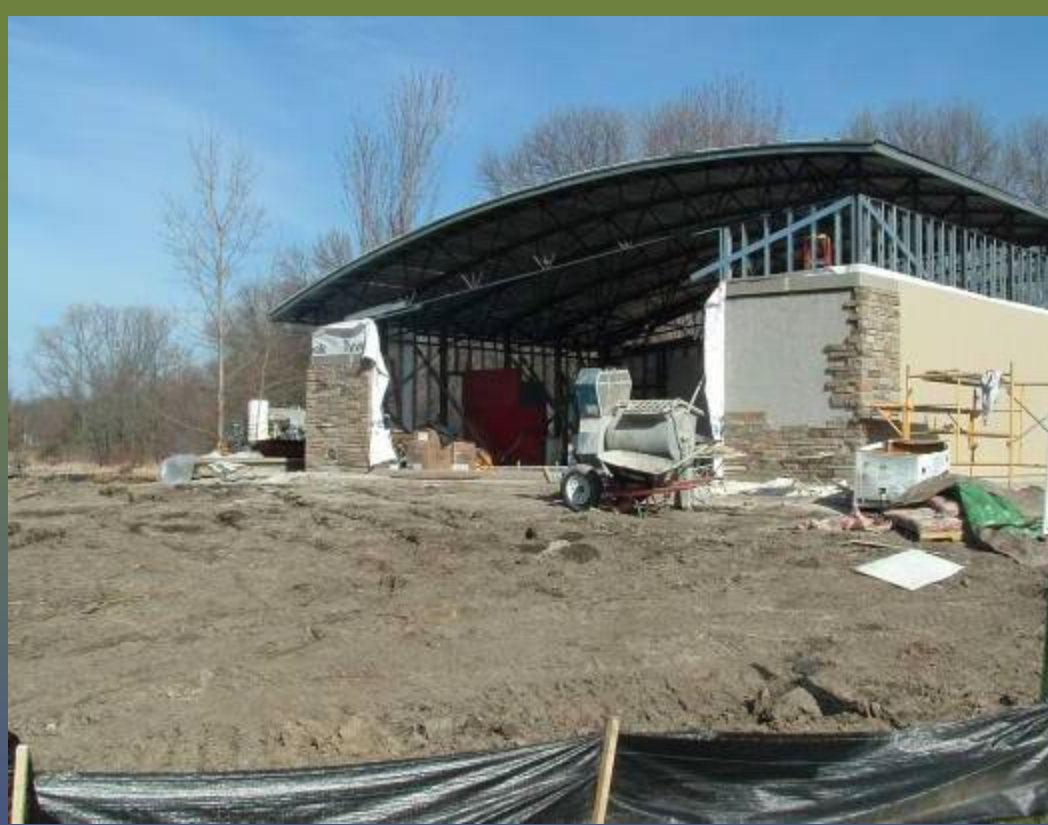
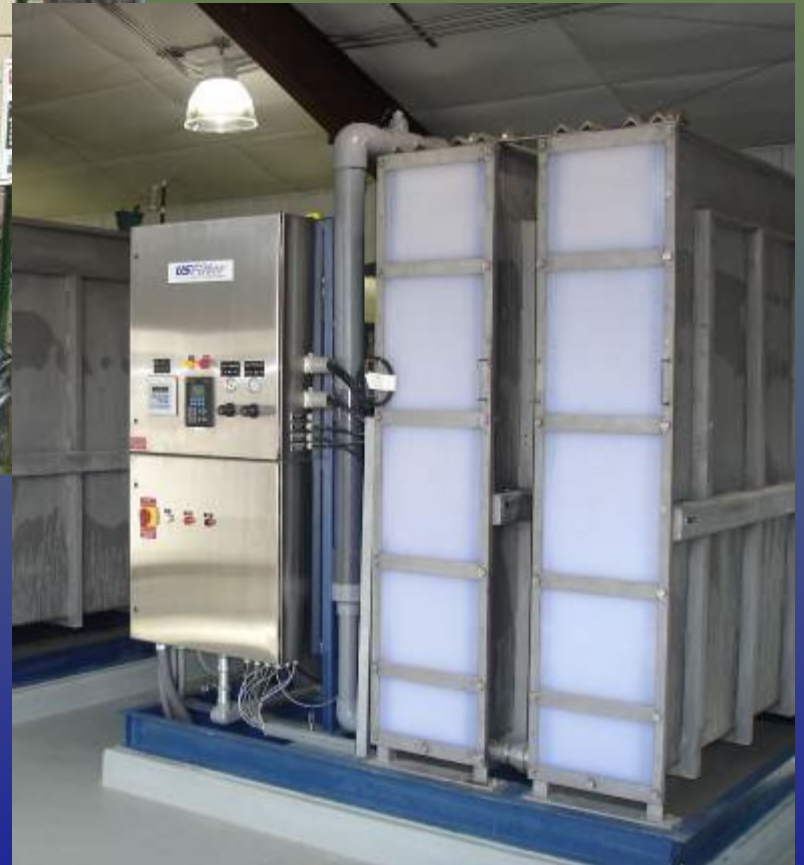
Filters

- Microfiltration ($0.1 \mu\text{m}$) removes sediment that could clog recharge bed & particulate pollutants.
- Backwash discharged to sanitary sewer.

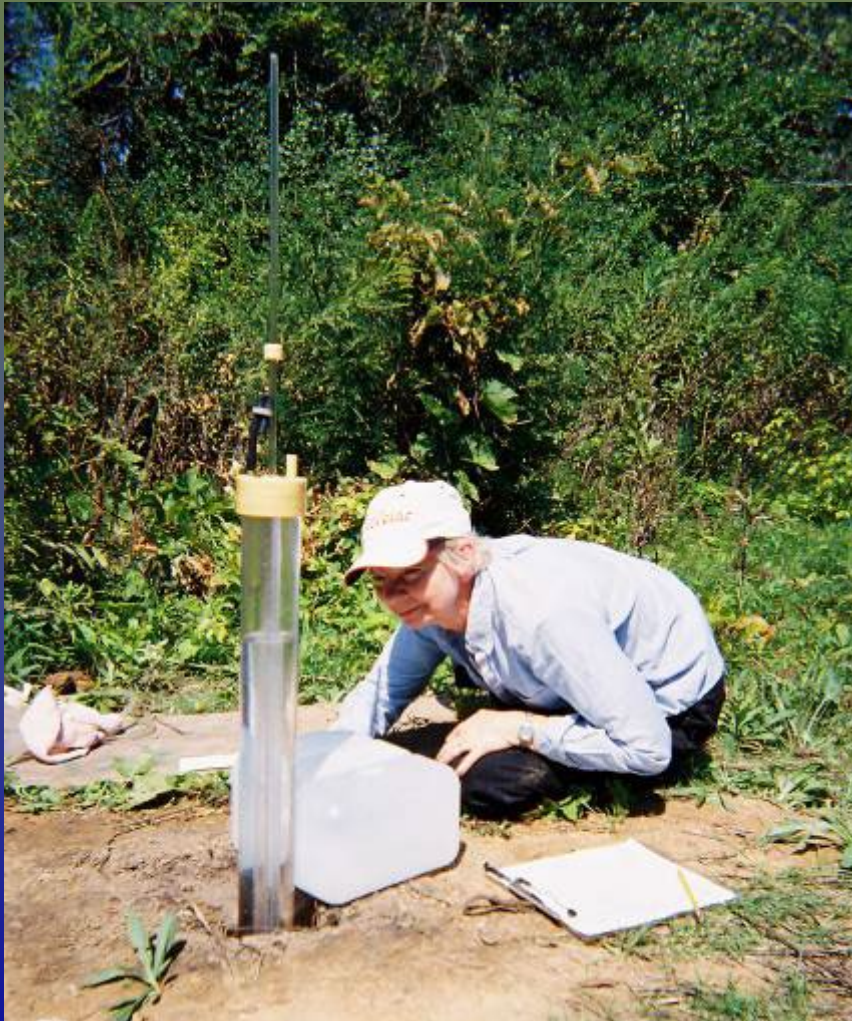
Soil & Hydrogeologic Evaluation

- Soil borings and monitoring wells
- Laboratory tests for soil grain size & permeability
- Field field infiltration tests & aquifer tests
- Soil (just) permeable enough at depth

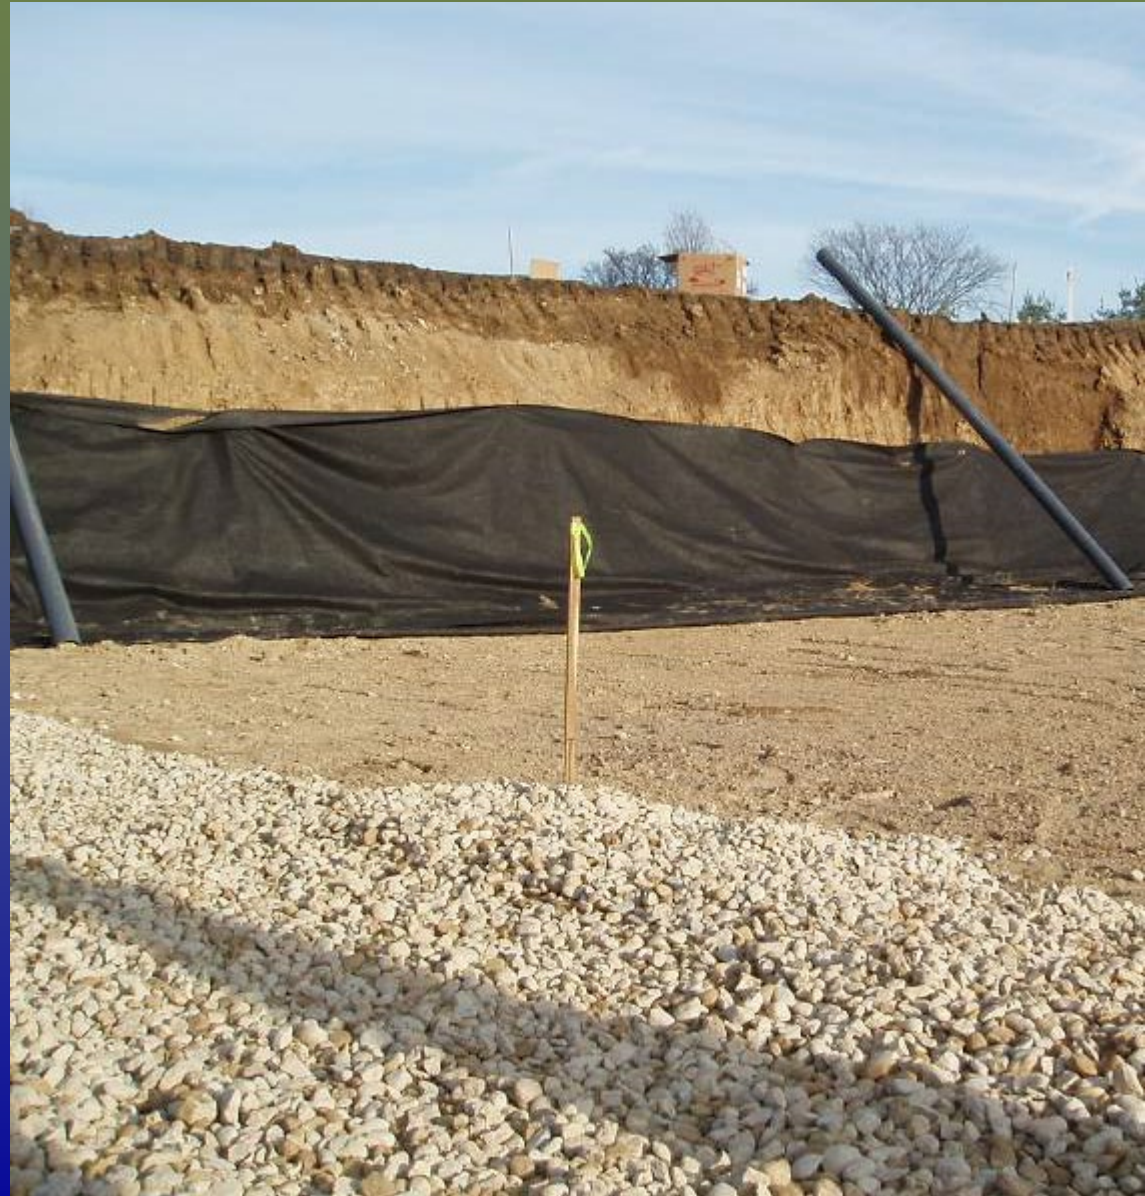
Subsurface Recharge Bed

- Excavated ~10 ft deep
- Clear stone & piping to distribute water
- Monitoring wells
